National
Transportation
Safety Board

M/V Trinity II Survival Factors

Liam LaRue

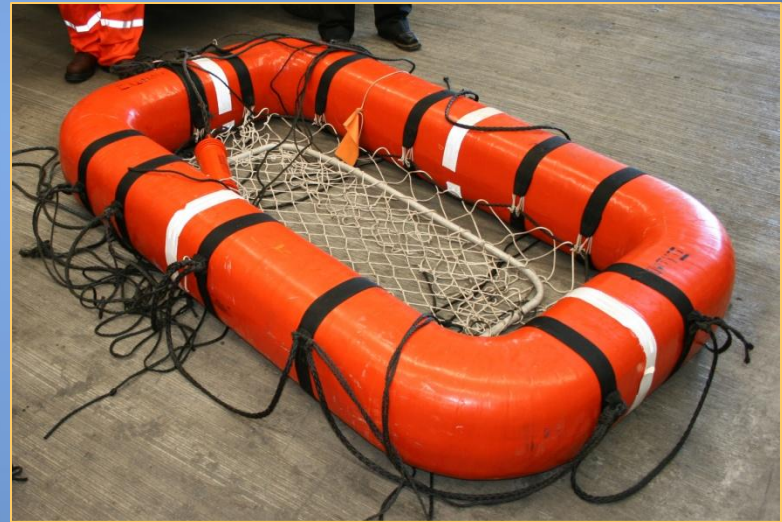
Abandon Ship

- All personnel moved to main deck
- Contractors retrieved a lifefloat
- All personnel remained together with the lifefloat

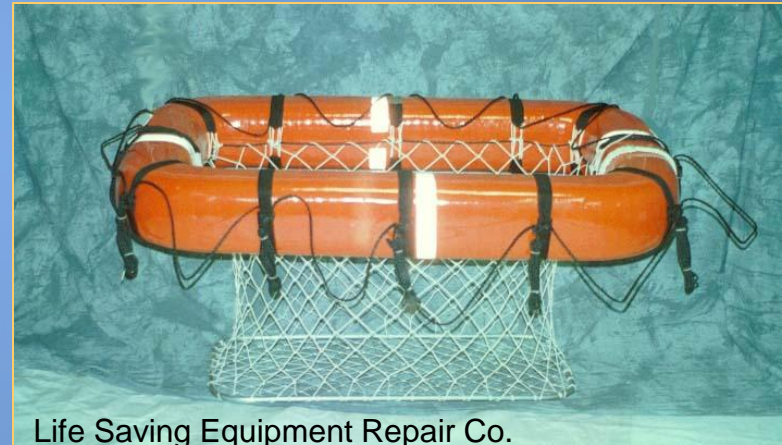
In-Water-Survival

- Heavy Weather Thursday and Friday
- No out-of-water flotation
- No food, water, or rest
